2005 6.0L DIT RUNNING CHANGES

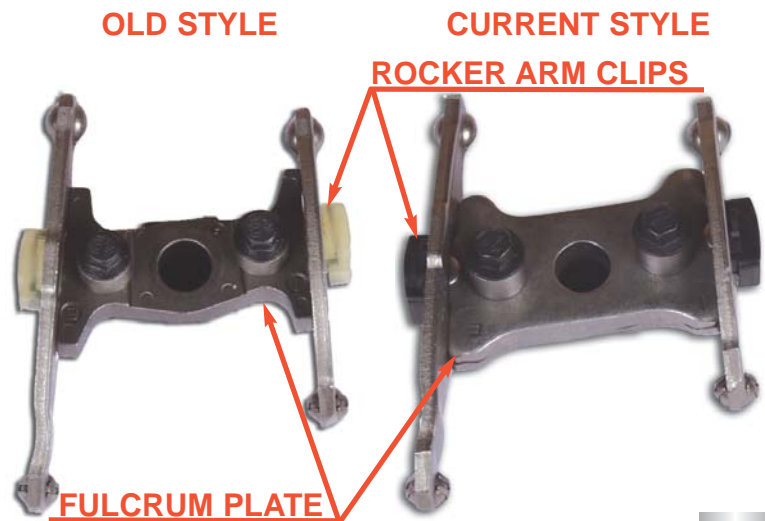
Rocker Arm Fulcrum Plate

- The rocker arm fulcrum plates have a new appearance due to a change in the manufacturing process.
- The plastic rocker arm clip has been made more robust by improving the plastic material.
- **NOTE: Service kits are available for the new fulcrum plates. The new design is reverse compatible with the previous design.**

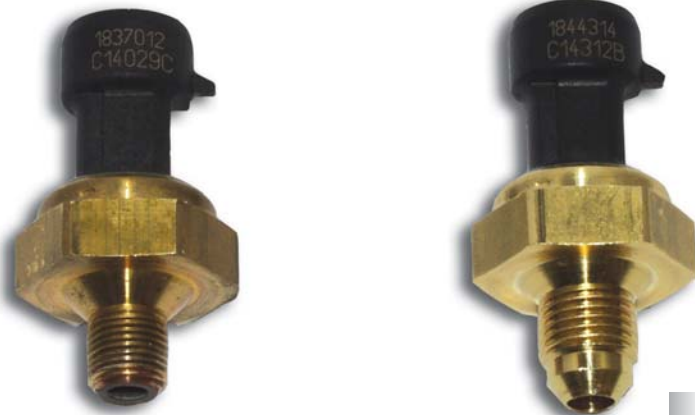
Exhaust Pressure Sensor

- The F-series vehicles now use the same Exhaust Pressure (EP) sensor as the E-series previously used.
- The sensor mounting threads changed to improve the parts commonality between the F-series and E-series vehicles.

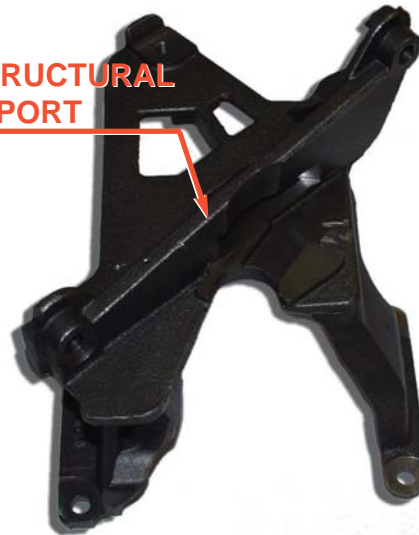
Current Turbocharger Bracket

- The current production turbocharger bracket has been made more robust by adding material across the center of the bracket.
- The new design minimizes the moan/droan concerns.
- The current bracket went into production on January 5, 2005 beginning with engine serial number 6470111 for Indianapolis built engines and engine serial number 0189356 for Huntsville built engines.
- **NOTE: The current bracket is reverse compatible with 2004.25 and early 2005 MY engines.**

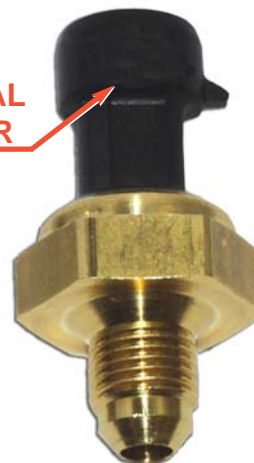
Optimized Exhaust Pressure Sensor

- A new Exhaust Pressure (EP) sensor went into production on January 14, 2005.
- The new sensor incorporates an improved ceramic sensing disc that is less susceptible to exhaust corrosion.
- The optimized sensor can be identified by the International part number 1850353C1 or 1850352C1 located near the top of the sensor body.
- **NOTE: The optimized EP sensor is available as a service part for 2003.25, 2004.25, and early 2005 MY engines which use different mounting threads.**

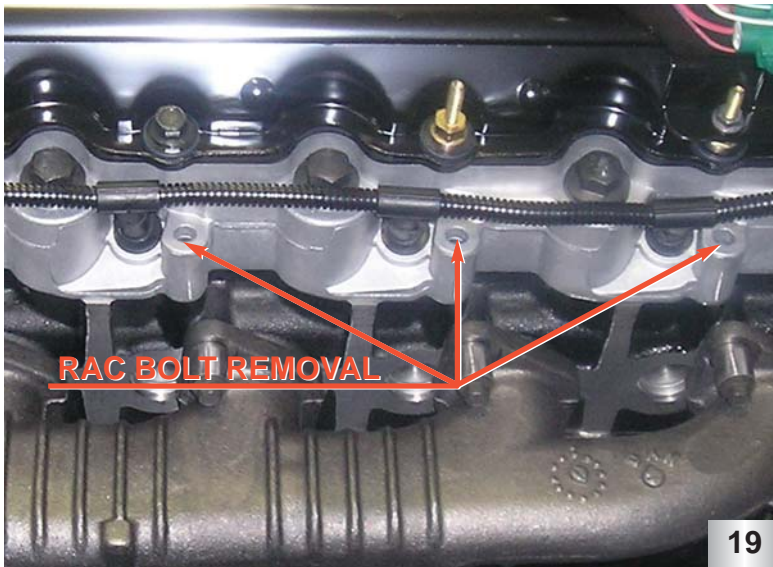
Rocker Arm Carrier (RAC) Bolts

- The cylinder head is now manufactured without the four outer rocker arm carrier (RAC) hold down bolt holes.
- The rocker arm carrier (RAC) still has the bolt holes in the casting with no bolts installed.
- The reason for the change is the clamp load provided by the cylinder head bolts is sufficient to for the rocker carrier.
- This change began with engine serial number 6537996 on April 5, 2005 on Indianapolis built engines.
