Technician Turbocharger Guide for the Powerstroke Engine

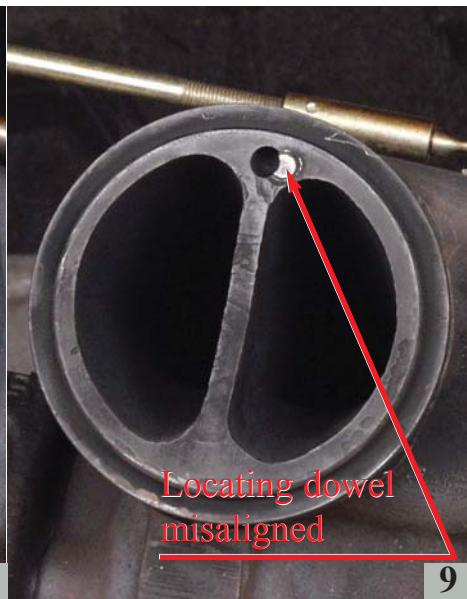
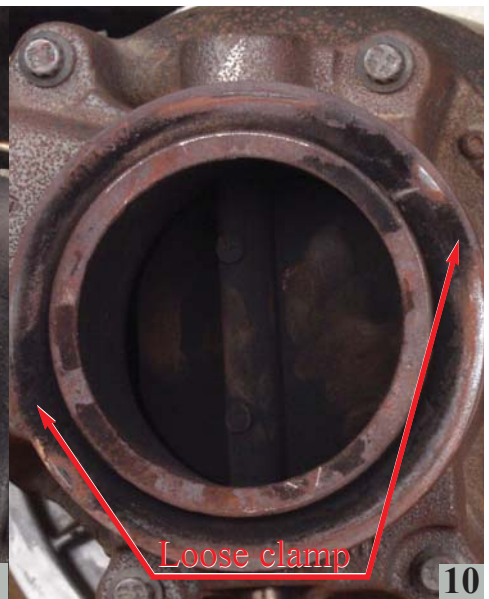
Turbochargers have been replaced for noise concerns when the concern is exhaust mis-alignment at the connections. Carefully inspect the exhaust connection at the inlet to the turbine housing, and the turbine exhaust outlet to exhaust pipe connection. Mis-alignment at these connections will often produce noise complaints. Re-aligning and tightening the V-band clamp can often repair the noise concern. If the turbocharger itself is responsible for excessive noise, expect to find wheel to housing rub, and bearing failure, as illustrated in photo 4.

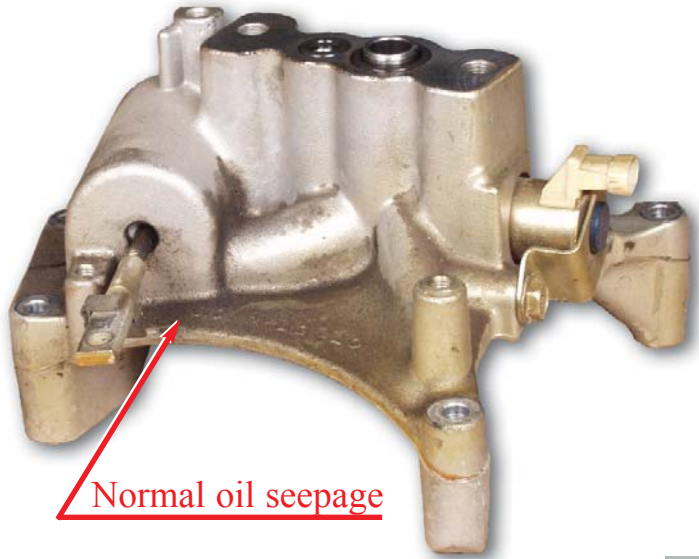
Normal Oil Seepage: It is normal to see some oil seepage past the seal on the EBP actuator rod. The photo to the left shows this normal seepage.

OIL LEAKS

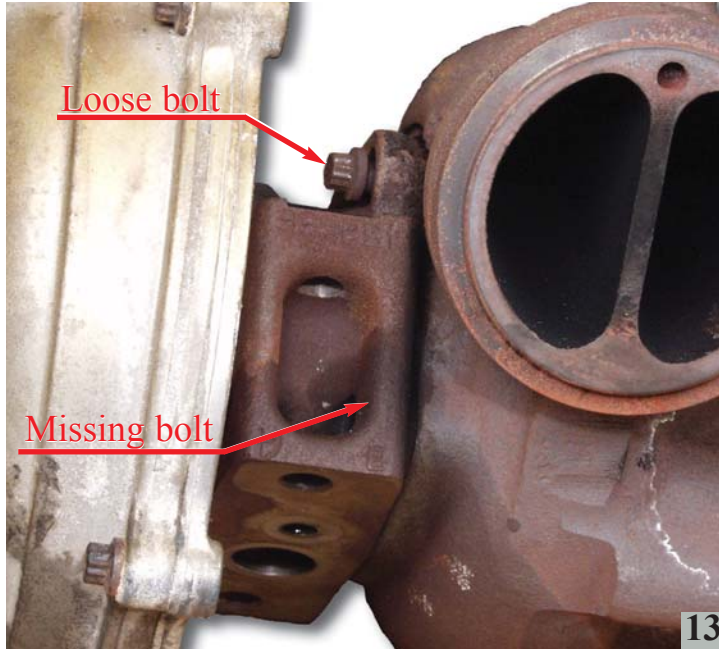
Some turbochargers have experienced turbine housing mounting bolt back out. This does not require turbocharger replacement unless the turbine wheel has contacted the housing and been damaged. Replacement bolts with an interference thread for improved retention are available for service. SSM 15998 (which supercedes SSM 14753) advises that the part number for the bolt kit is 1C3Z-9G486-AA. Do not try to “chase” the threads on these bolts.

When loose or missing bolts are found, replace the bolts with part number 1C3Z-9G486-AA per SSM 15998.
