Technician Turbocharger Guide for the Powerstroke Engine

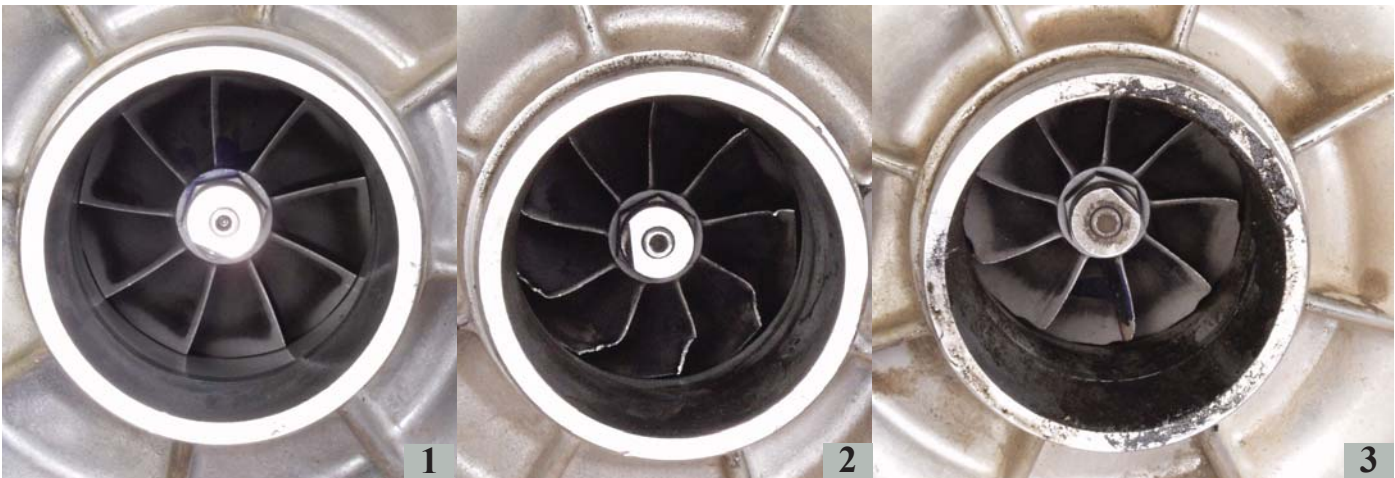
Good Turbocharger:

Compressor blades are clean and straight. There are no large gaps between the compressor housing and the compressor wheel. No visible damage to blades. This turbocharger should not be replaced.

Foreign Object Damage:

This compressor wheel shows signs of some outside object (nuts, bolts, screws, etc.) coming in contact with the blades while they were spinning.

Dirt Ingestion:

Also called dusting. The compressor wheel blades show signs of erosion from dirt entering the intake air system. The blades are rounded off and there is dirt accumulation in the compressor inlet.

Note: If damage to the compressor wheel is found, the intake air system should be cleaned and inspected for foreign objects, poor maintenance, broken components, or improper installation.

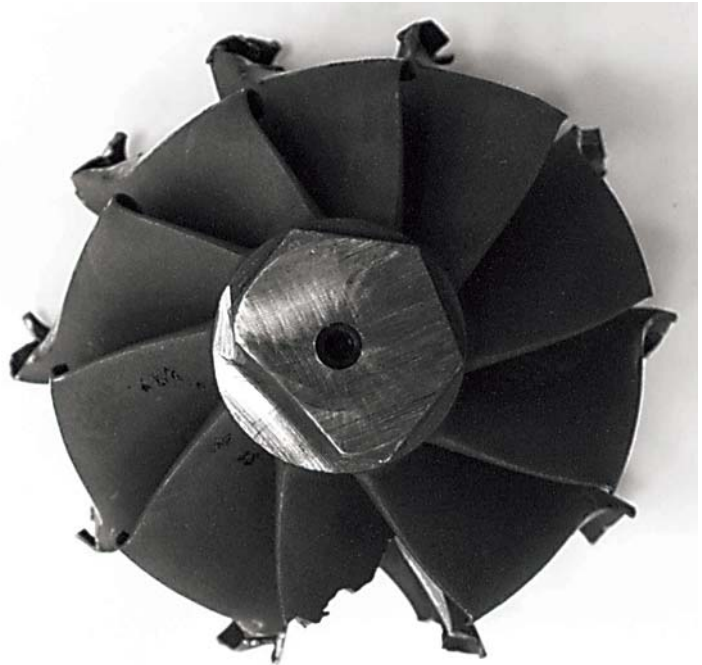
16

Structural Failure: Above right is a turbine wheel that has failed due to overspeed as a result of performance modifications.
