# Technician Turbocharger Guide for the Powerstroke Engine

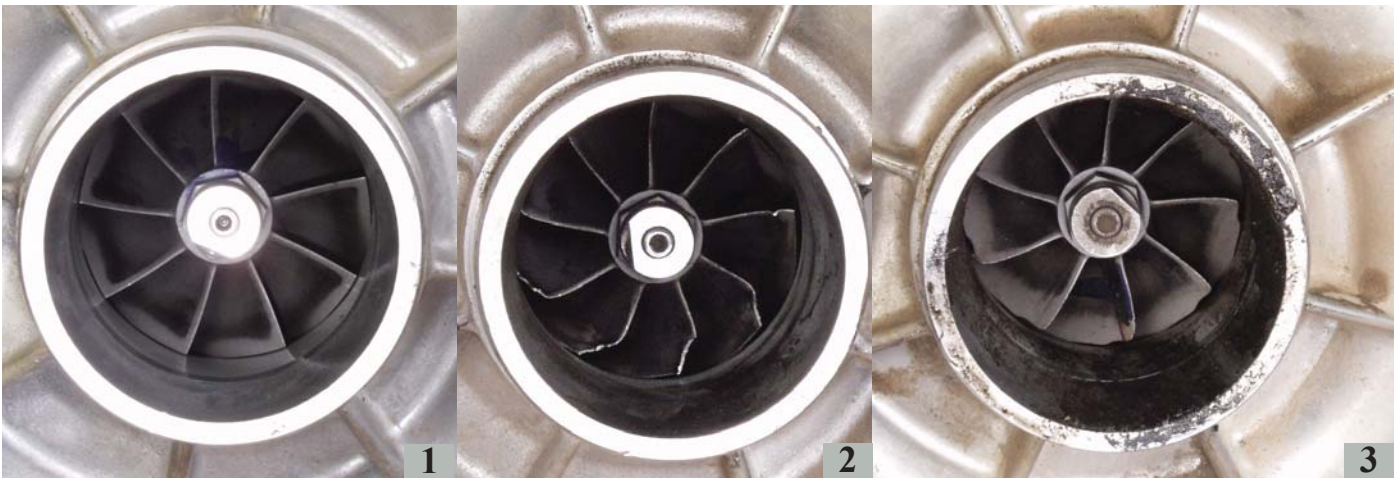
### Good Turbocharger:

Compressor blades are clean and straight. There are no large gaps between the compressor housing and the compressor wheel. No visible damage to blades. This turbocharger should not be replaced.

### Foreign Object Damage:

This compressor wheel shows signs of some outside object (nuts, bolts, screws, etc.) coming in contact with the blades while they were spinning.

### Dirt Ingestion:

Also called dusting. The compressor wheel blades show signs of erosion from dirt entering the intake air system. The blades are rounded off and there is dirt accumulation in the compressor inlet.

**Note:** If damage to the compressor wheel is found, the intake air system should be cleaned and inspected for foreign objects, poor maintenance, broken components, or improper installation.

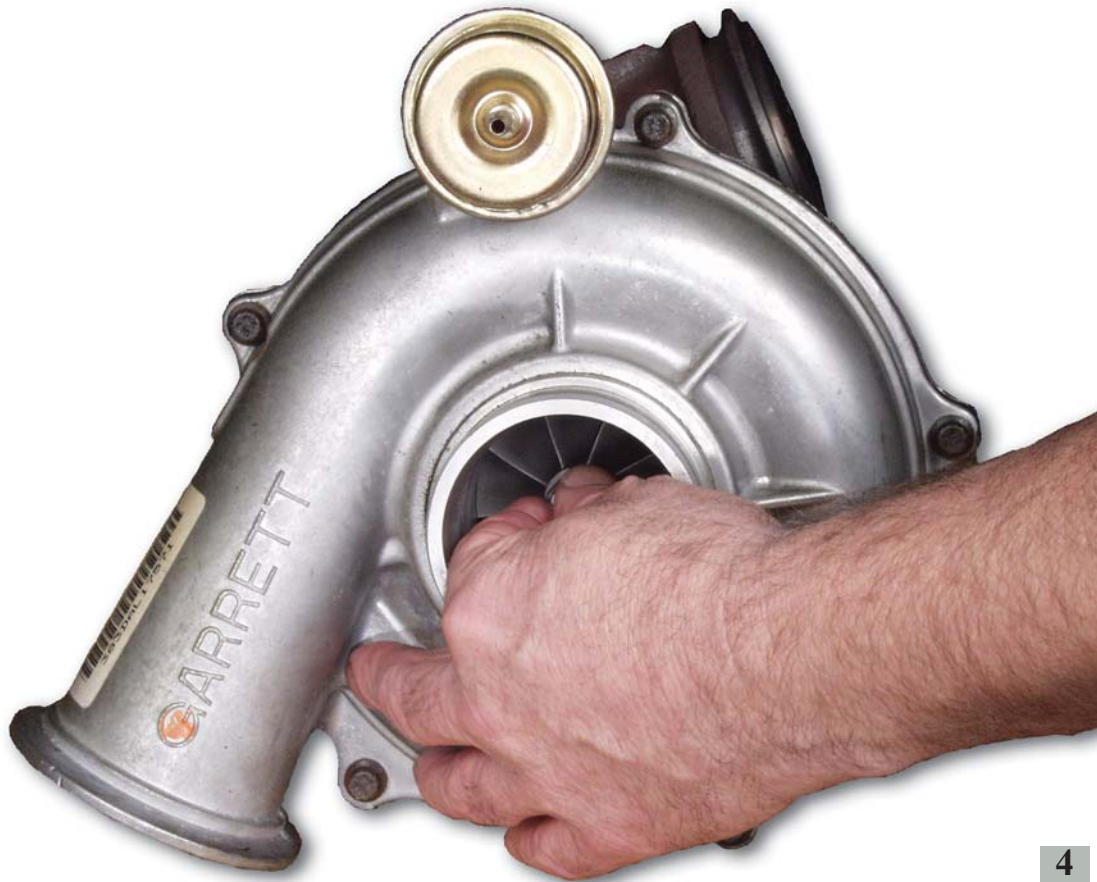
4

Does any evidence of wheel to housing contact exist, such as witness marks on the housing or rolled edges on the wheel? Before testing a service part replacement, pour some clean oil into the lube oil passages.

Spin the compressor wheel to make sure that it spins freely. The wheel should not contact the housing.

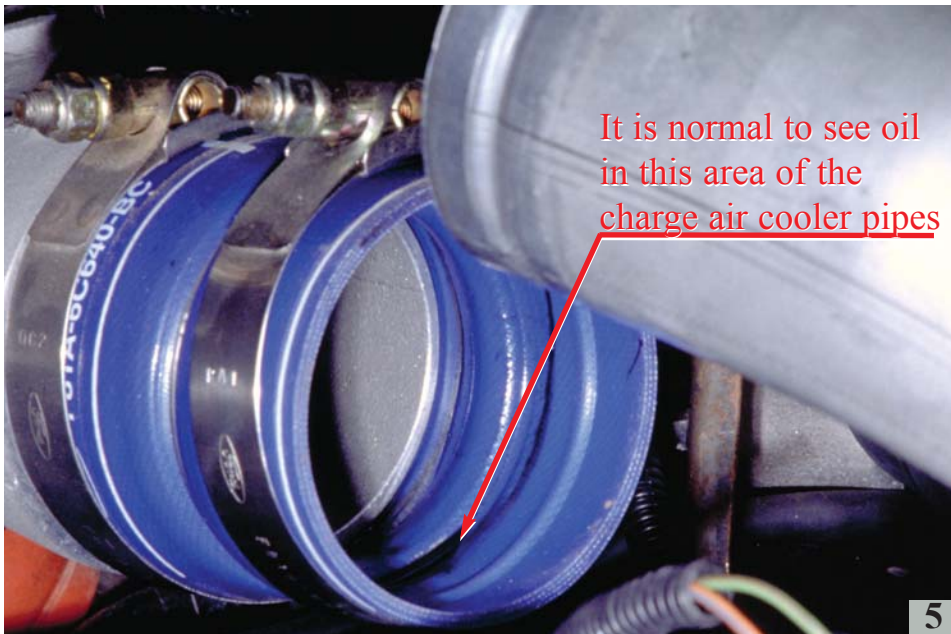
**Normal Oil Carryover:** The photo to the left shows normal oil carryover in the charge air cooler pipes. This condition can be aggravated by excessive air inlet restriction. The turbocharger should not be replaced for this condition.

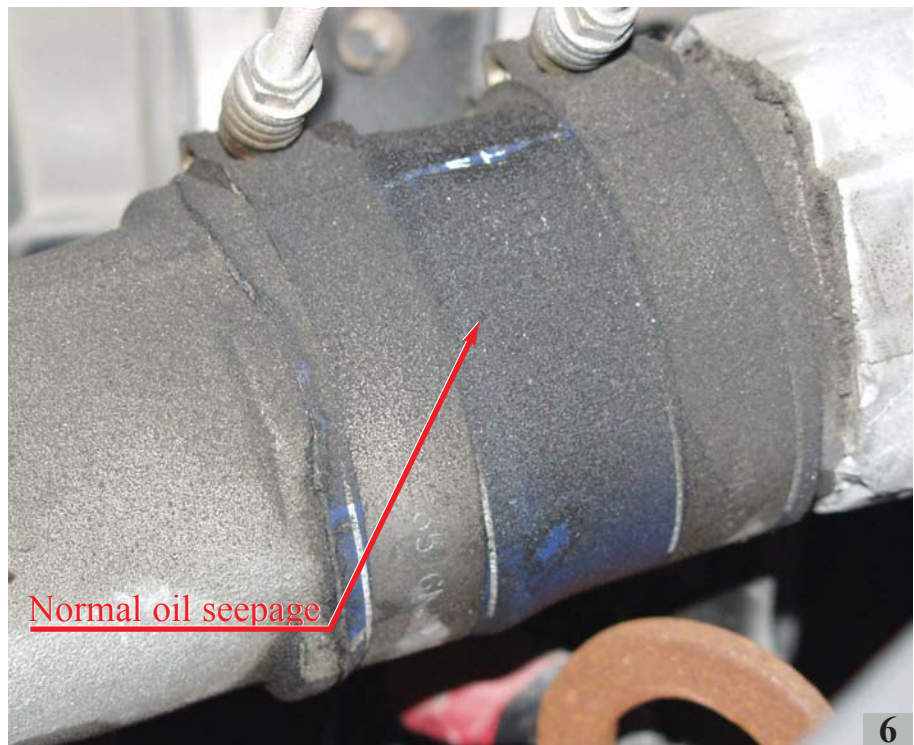
**Normal Oil Seepage:** The photo to the right shows normal oil seepage on the charge air cooler connections. This condition can be aggravated by excessive air inlet restriction or an overfilled crankcase oil level (refer to SSM 11982). The turbocharger should not be replaced for this condition.

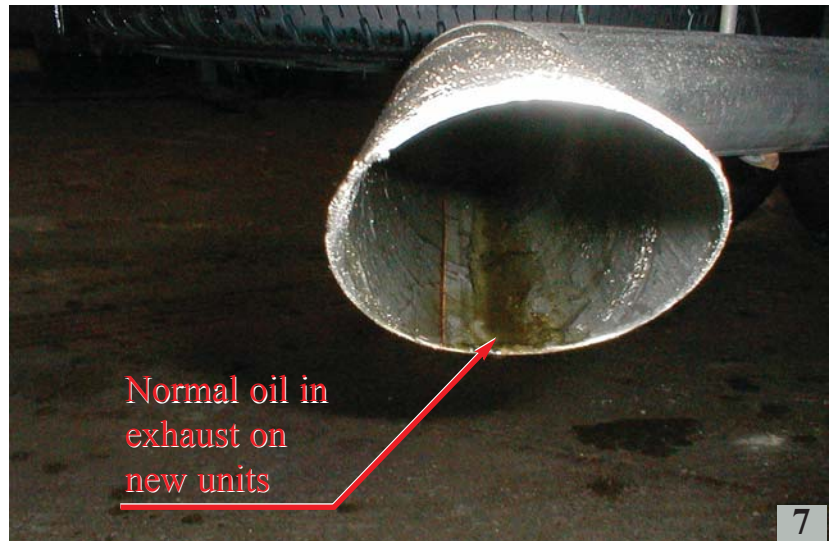
On very low mileage trucks, (typically less than 1000 miles) some turbochargers have been replaced because of an "oily residue" exiting the exhaust pipe. Be aware that during the manufacture of exhaust pipes, lubricants are used in the bending process and to prevent rust. Do not consider replacing the turbocharger just because oil is coming out of the tailpipe. The initial oil in the engine has had dye added, so inspect with a blacklight first. If it is thought that the oil is from the engine, loosen the exhaust pipe from the turbocharger outlet and look for signs of engine oil exiting the turbocharger. If the turbocharger is leaking oil into the exhaust, expect to find the bearings in the unit to be worn and for wheel rub to be present.

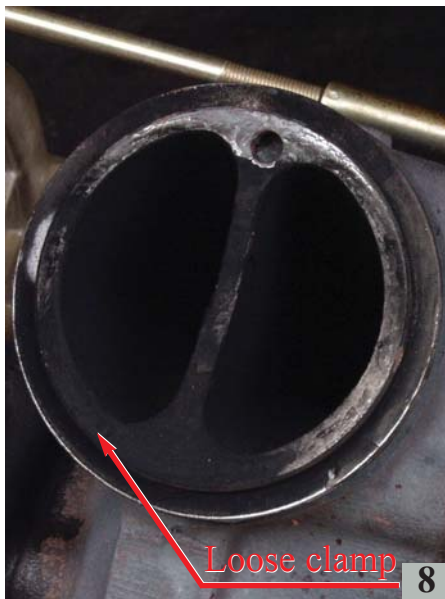
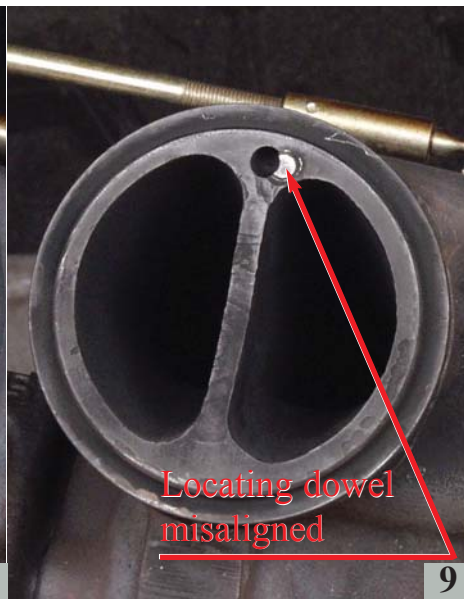
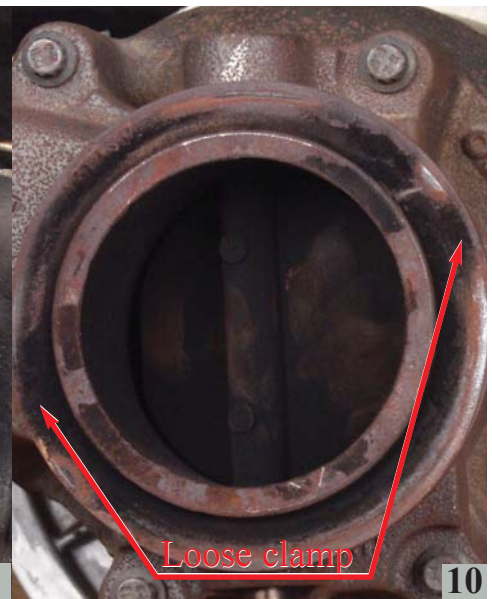
Turbochargers have been replaced for noise concerns when the concern is exhaust mis-alignment at the connections. Carefully inspect the exhaust connection at the inlet to the turbine housing, and the turbine exhaust outlet to exhaust pipe connection. Mis-alignment at these connections will often produce noise complaints. Re-aligning and tightening the V-band clamp can often repair the noise concern. If the turbocharger itself is responsible for excessive noise, expect to find wheel to housing rub, and bearing failure, as illustrated in photo 4.

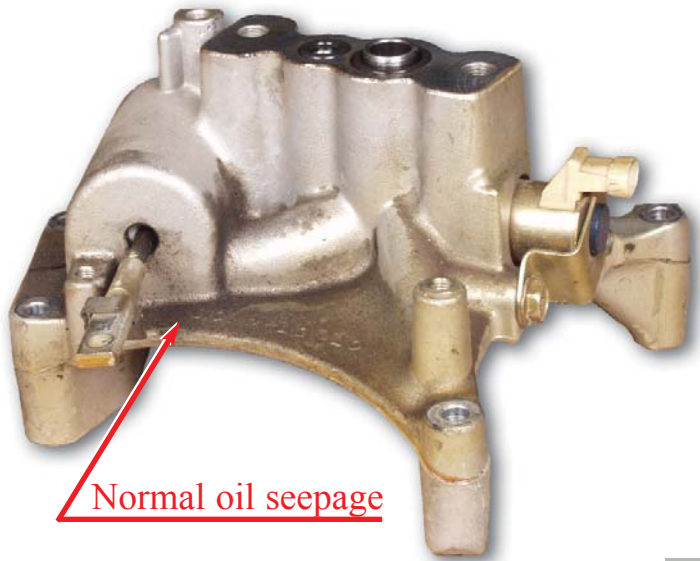
11

**Normal Oil Seepage:** It is normal to see some oil seepage past the seal on the EBP actuator rod. The photo to the left shows this normal seepage.

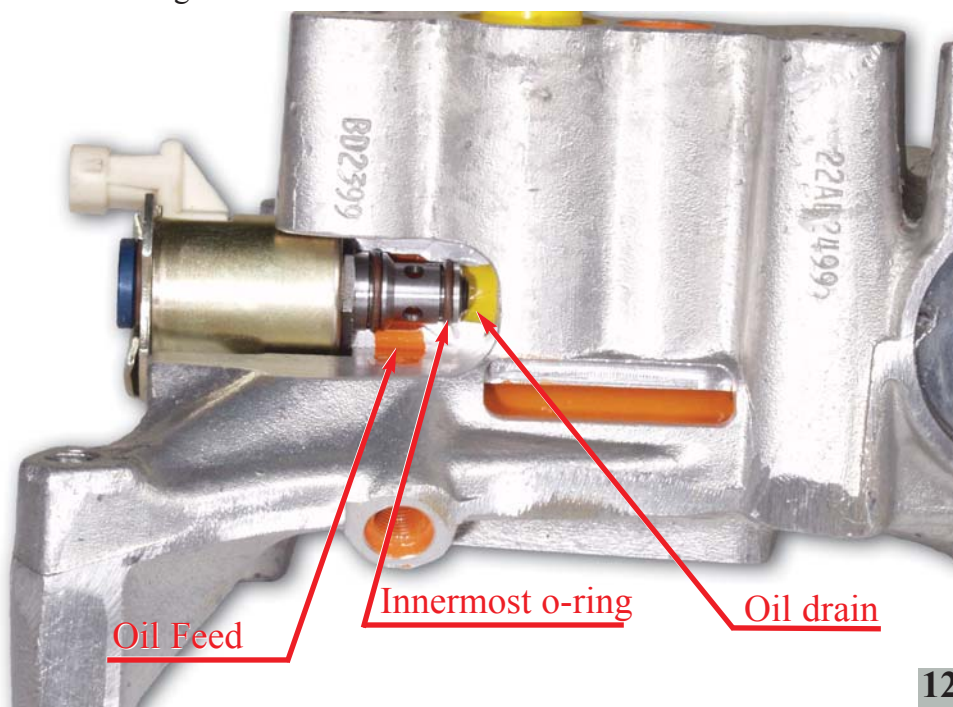
12

Turbochargers have been replaced when the exhaust backpressure system (EBP) malfunctions. If performance is low, disconnect the EBP actuator rod from the bell crank, and tie the valve open. If this resolves the performance concern, make sure the valve in the exhaust rotates freely. If it does, then suspect the regulator to be at fault. The exhaust backpressure regulator and the regulator o-rings can be serviced separately from the turbocharger.

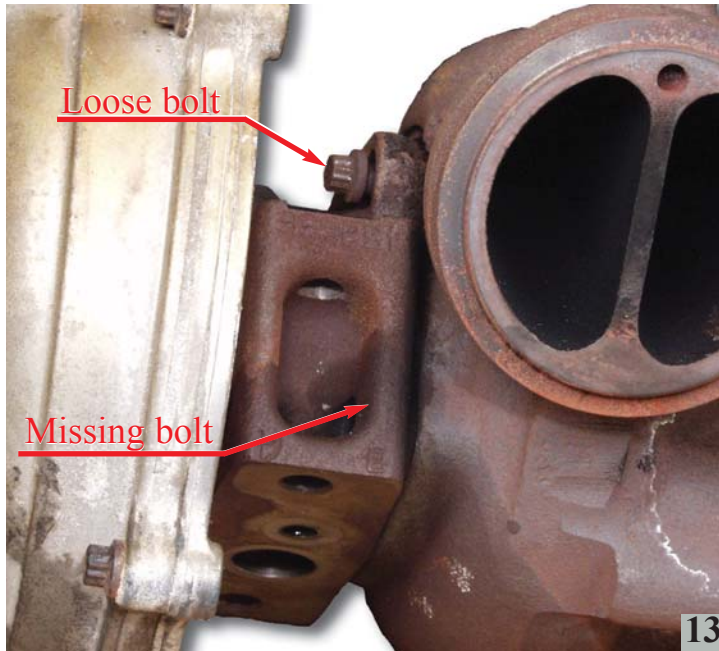
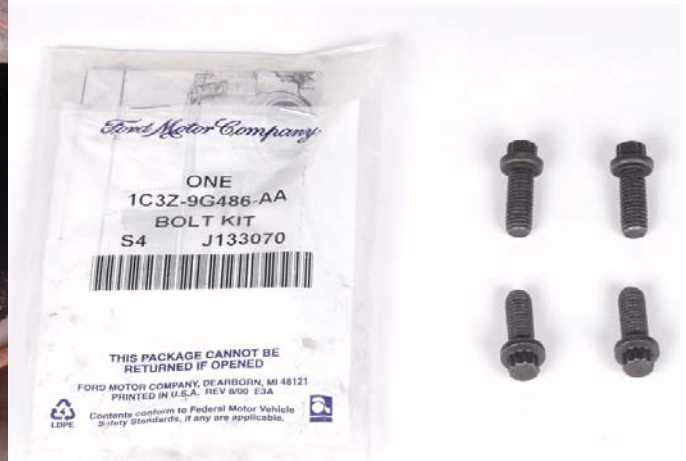
Some turbochargers have experienced turbine housing mounting bolt back out. This does not require turbocharger replacement unless the turbine wheel has contacted the housing and been damaged. Replacement bolts with an interference thread for improved retention are available for service. SSM 15998 (which supercedes SSM 14753) advises that the part number for the bolt kit is 1C3Z-9G486-AA. Do not try to “chase” the threads on these bolts.

When loose or missing bolts are found, replace the bolts with part number 1C3Z-9G486-AA per SSM 15998.

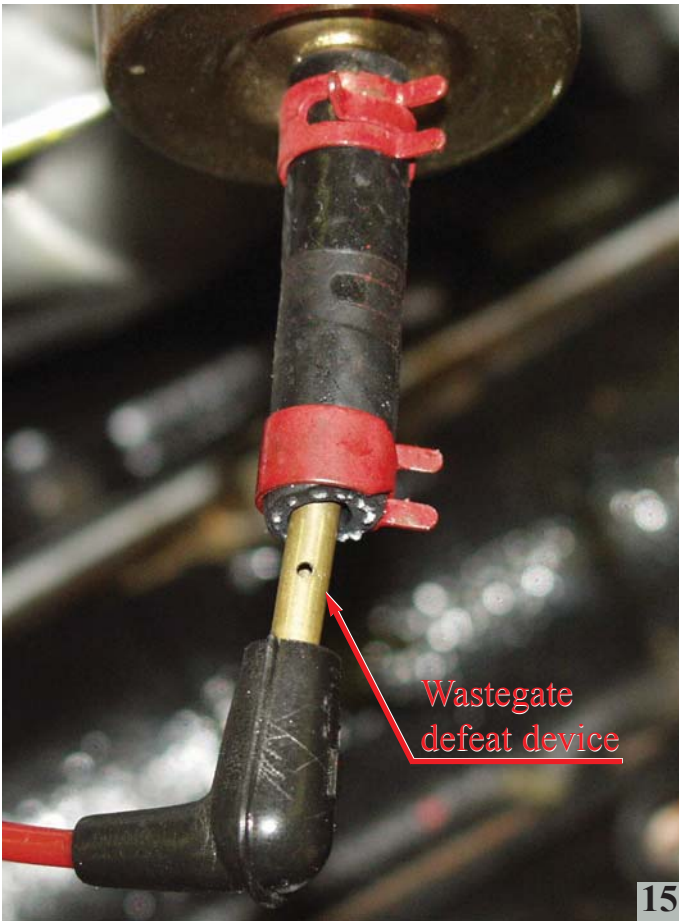
15

**Aftermarket Performance Enhancers:** Above left is a wastegate actuator defeat device which will not allow the wastegate to operate correctly.

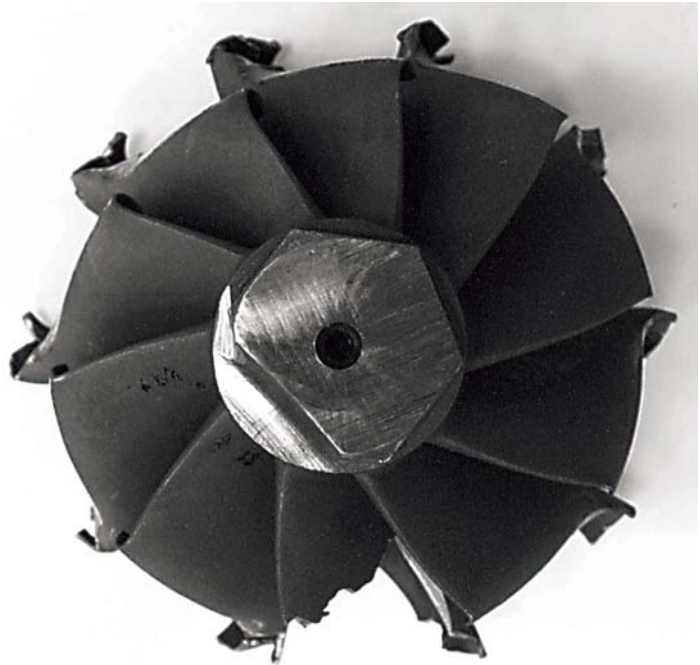
16

**Structural Failure:** Above right is a turbine wheel that has failed due to overspeed as a result of performance modifications.
