# Technician Turbocharger Guide for the 6.0L *Power Stroke* Engine

# TURBOCHARGER DESCRIPTION AND BASIC OPERATION

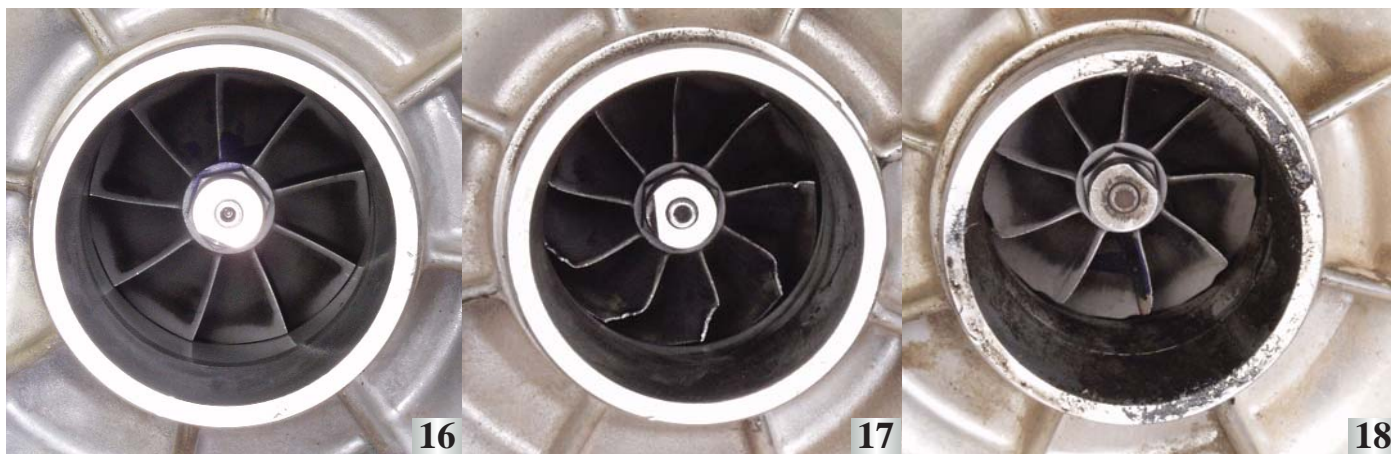
## BLADE DAMAGE

### Good Turbocharger:

Compressor blades are clean and straight. There are no large gaps between the compressor housing and the compressor wheel. No visible damage to blades. This turbocharger should not be replaced.

### Foreign Object Damage:

This compressor wheel shows signs of some outside object (nuts, bolts, screws, etc.) coming in contact with the blades while they were spinning.

### Dirt Ingestion:

Also called dusting. The compressor wheel blades show signs of erosion from dirt entering the intake air system. The blades are rounded off and there is dirt accumulation in the compressor inlet.

**Note:** For 6.0L Powerstroke diesel engines with engine oil diluted with four or more quarts of fuel, the turbocharger endplay needs to be checked (.001" - .004" allowable). Also check radial shaft movement by lifting the shaft up and rotating the shaft to check for compressor or turbine wheel to housing contact. If any wheel contact is noticed, the turbocharger must be replaced.

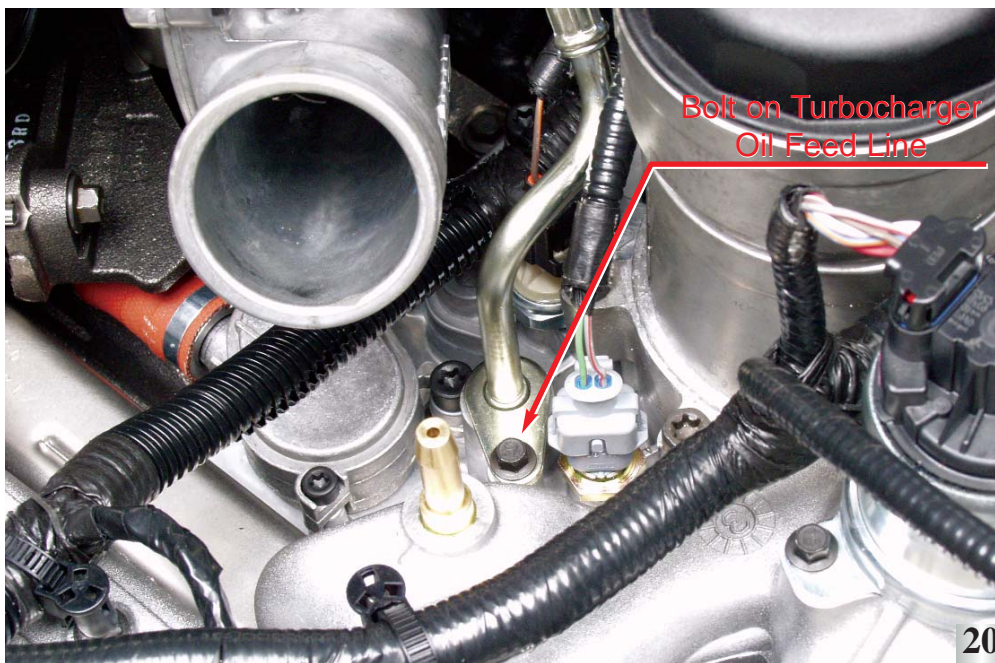
If oil is found leaking off of the back of the engine, one place to look would be the turbocharger since it is mounted in the valley. Some of the possible leak points would be from the oil supply connection, oil drain, center section, and oil seepage from the pipes.

When diagnosing any oil leak it is best to start at the top and most forward point of the affected area. An oil leak that looks like it is coming from the center section may be coming from the oil feed line.

The snap-to-connect turbocharger oil feed line has been replaced with an o-ring sealed, bolt-on line. This was done to reduce leaks due to improper installation.
