2005 6.0L DIT RUNNING CHANGES

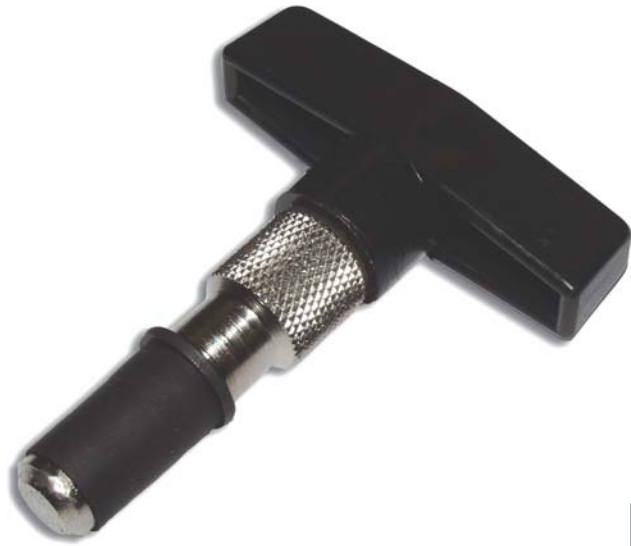
Stand Pipe Removal Tool

- This tool is used to remove the stand pipe from the branch tube if it separates from the high-pressure check valve during disassembly.
- Tool part number 303-1164.
