# Technician Turbocharger Guide for the 6.0L *Power Stroke* Engine

# TURBOCHARGER DESCRIPTION AND BASIC OPERATION

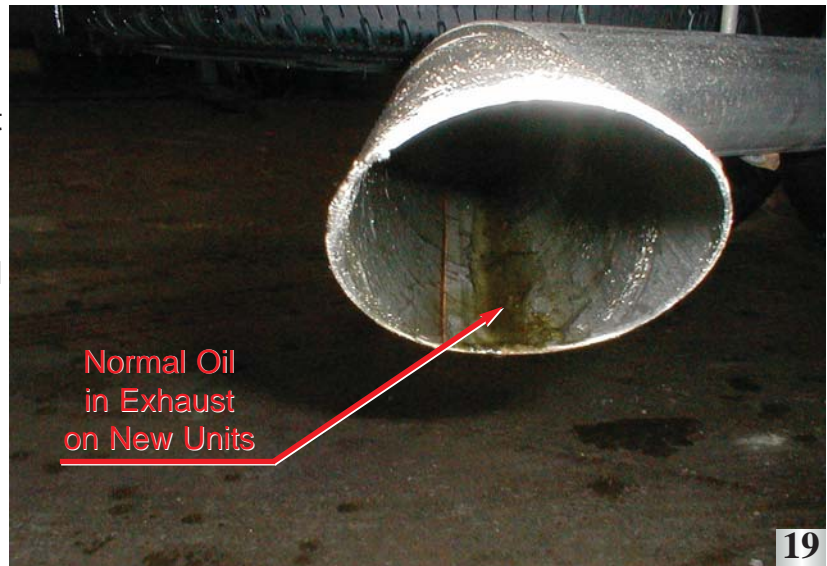
On very low mileage trucks, (typically less than 1000 miles) some turbochargers have been replaced because of an "oily residue" exiting the exhaust pipe. Be aware that during the manufacture of exhaust pipes, lubricants are used in the bending process and to prevent rust. Do not consider replacing the turbocharger just because oil is coming out of the tailpipe. The initial oil in the engine has had dye added, so inspect with a blacklight first. If it is thought that the oil is from the engine, loosen the exhaust pipe from the turbocharger outlet and look for signs of engine oil exiting the turbocharger. If the turbocharger is leaking oil into the exhaust, expect to find the bearings in the unit to be worn and for wheel rub to be present.
